File No.: VIS(2021-22)-PL89-083-099

VALUATION REPORT

INDUSTRIAL PLANT & MACHINERY

M/S. KUMAR STONE CRUSHER

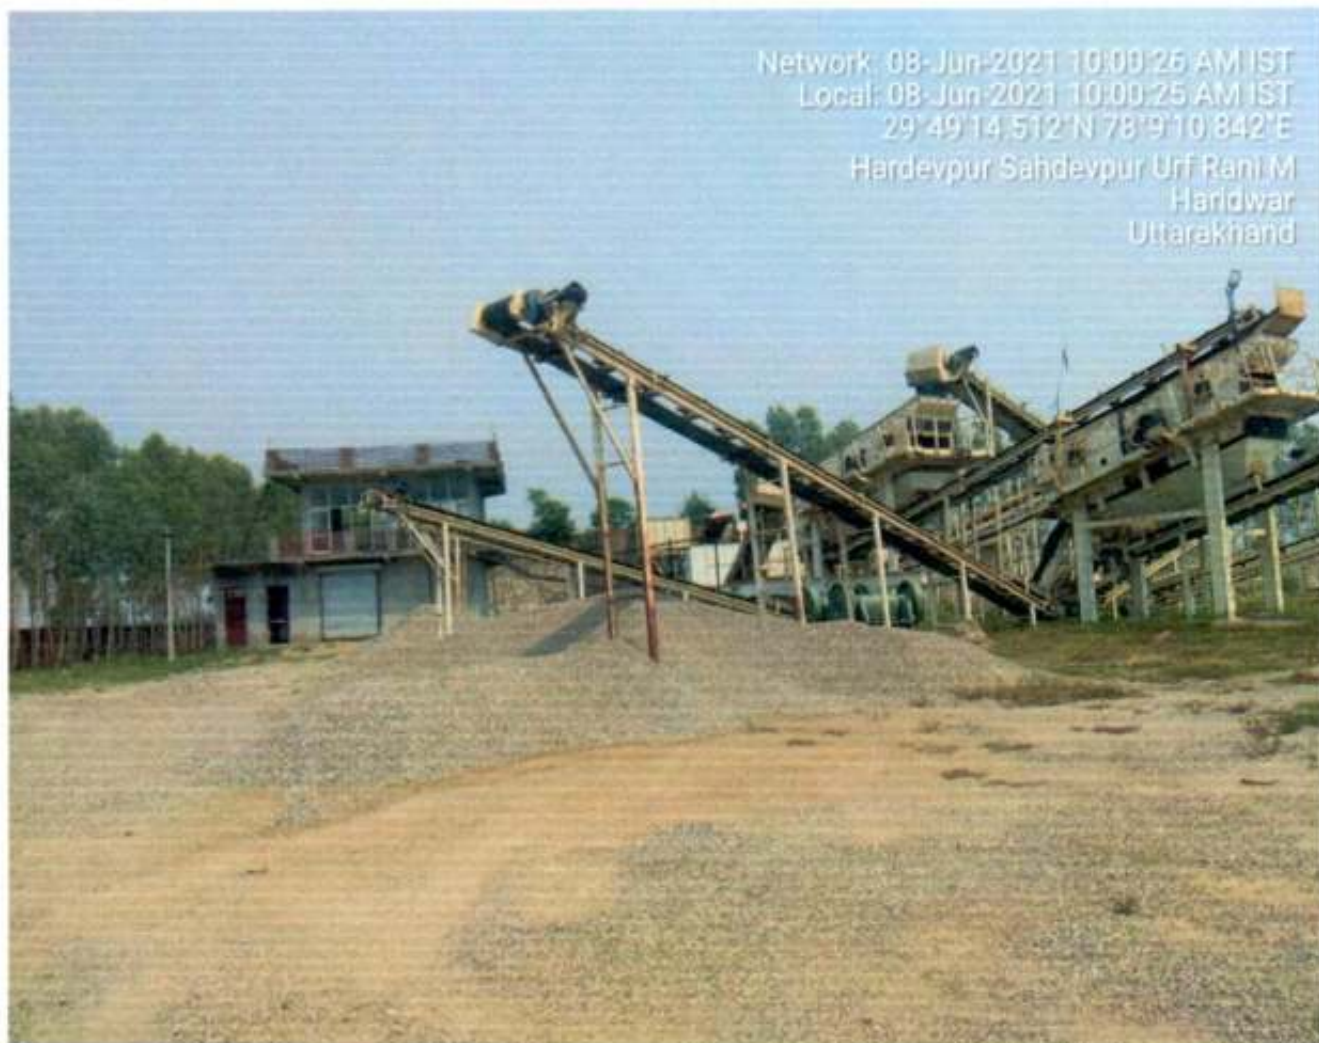
Snapshot of the Asset/ Property Under Valuation

M/s. Kumar Stone Crusher had commenced operations in the year 2016. They are the manufacturers and suppliers of stone chips of sizes 6, 10, 20, 40, 53 and 65 mm which are used for construction and road works. All plant machinery are local make and setup indigenous as per the information provided to us.

As per the site survey it was observed that the subject plant was not in operation since 2018 due to a ban imposed by the government on this industry. But it appears that maintenance has been carried out in the plant from time to time. Production is expected to start soon since a change in government policy is expected soon as per the information provided by the company's representative.

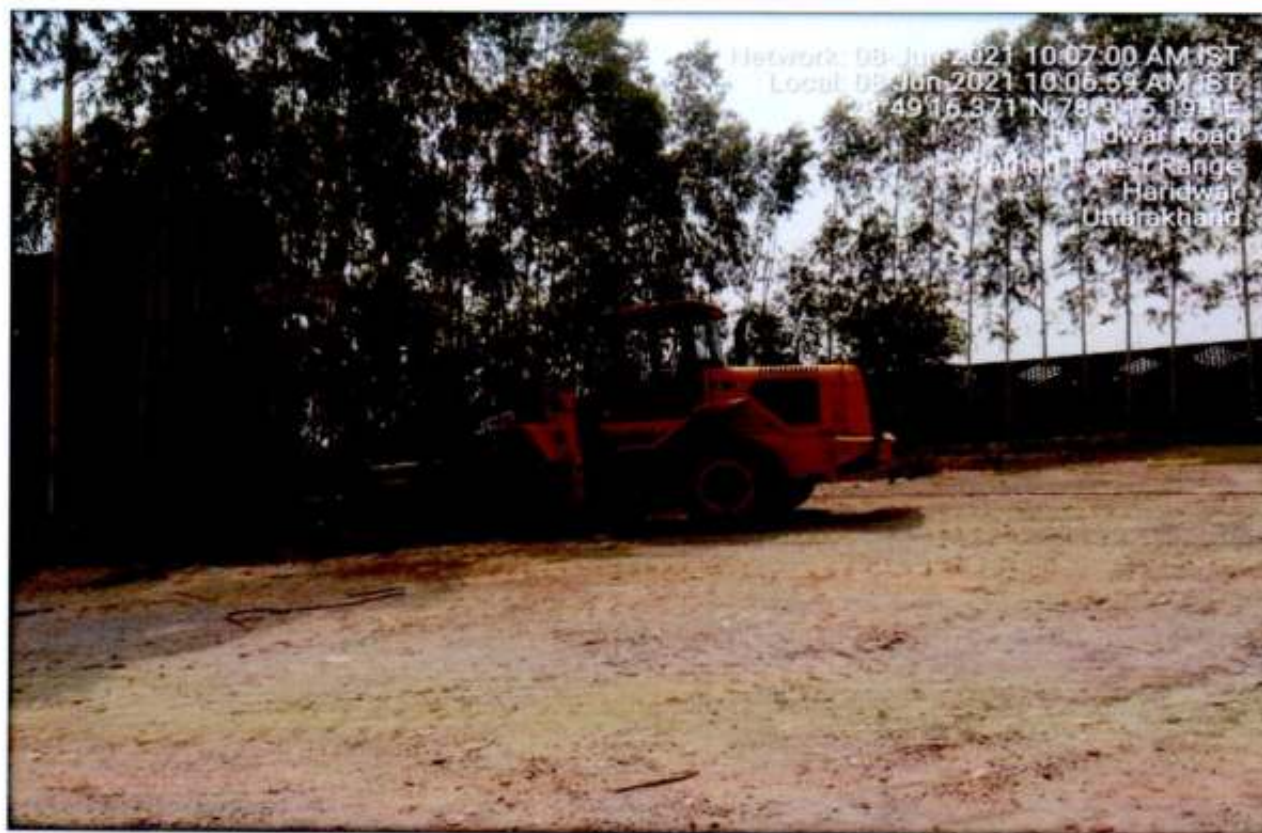
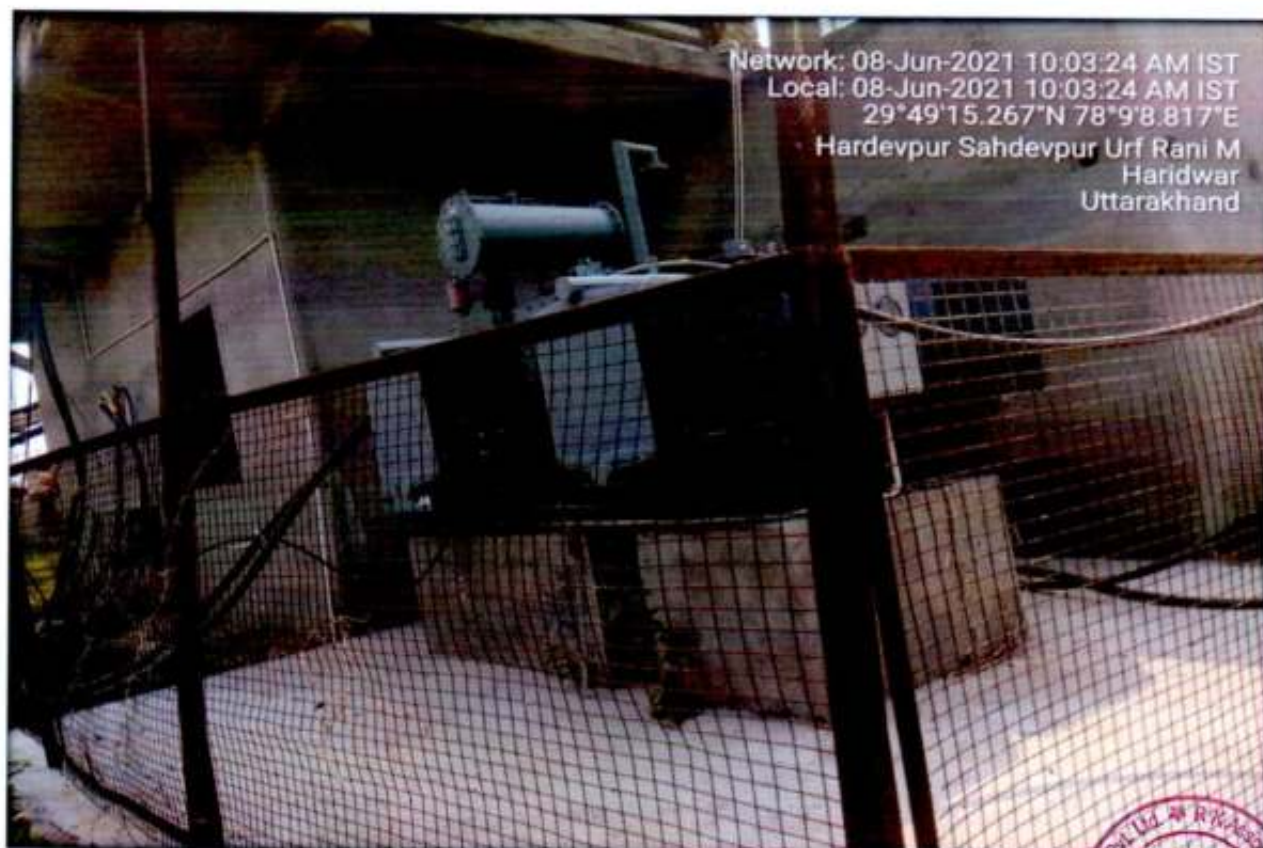
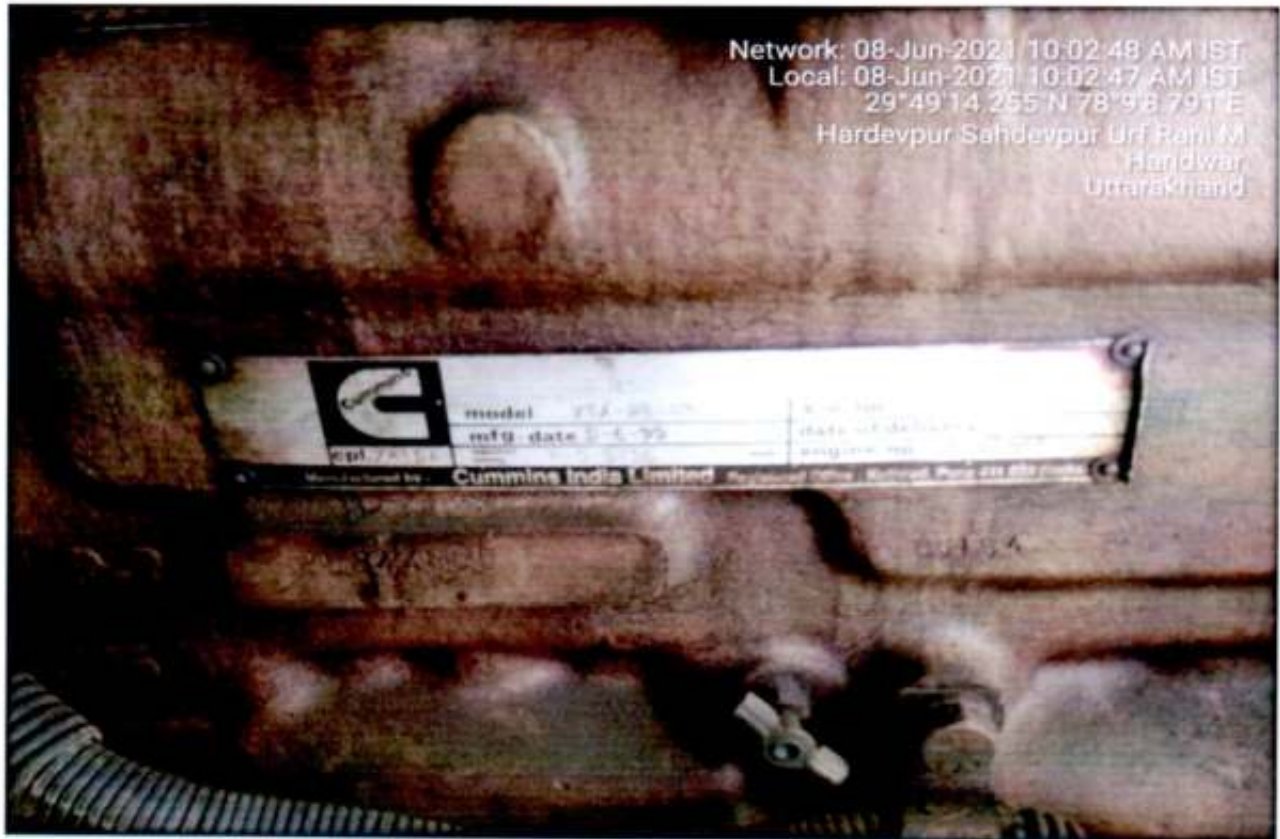
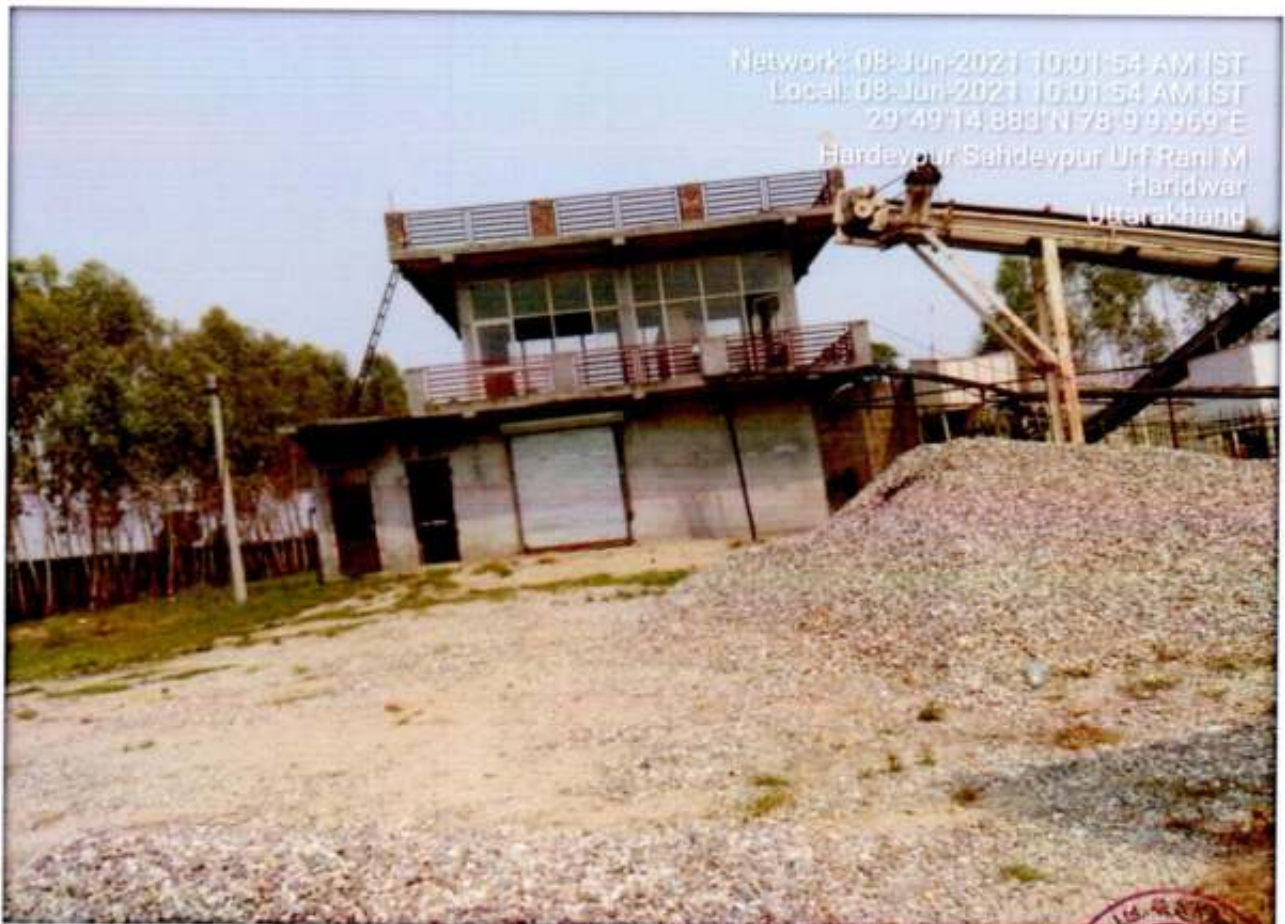
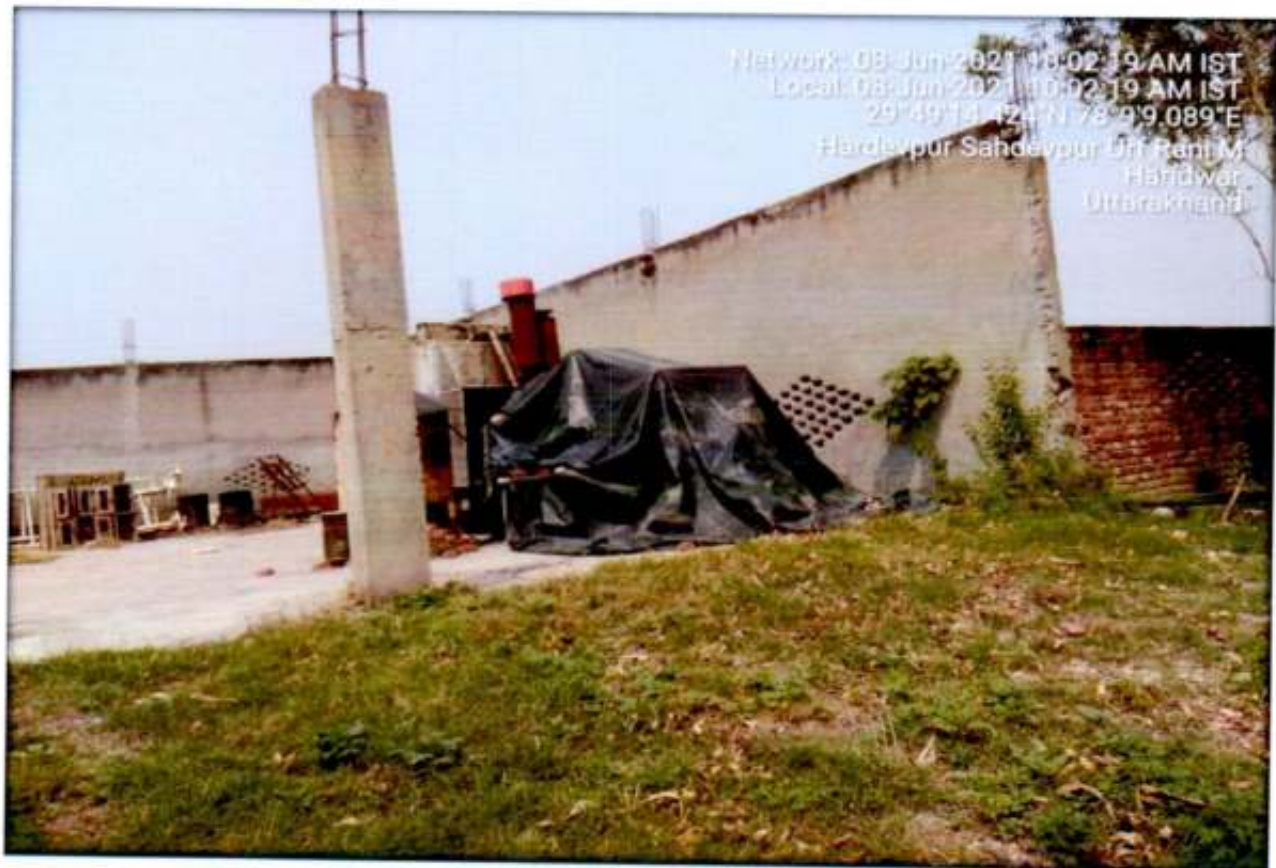
PHOTOGRAHS - ANNEXURE II

V.	Plant was not in operation since Feb. 2018 due to ban imposed by the government. But according to information provided by the owner's representative at the site, change in government policy is expected soon and hence the plant is expected to start operations soon. Hence they were carrying out maintenance in the plant.
VI.	All the details have been cross checked as per the documents provided to us by the bank and what was observed at the site.
VII.	Condition of the machines is checked through visual observation only. No technical/ mechanical/ operational testing has been carried out to ascertain the condition and efficiency of machines.
VIII.	Site Survey has been carried out on the basis of the physical existence of the assets rather than their technical expediency.
IX.	As per the overall site visit summary, machines appeared to be in average condition and some maintenance appears to be carried out on the machines time to time.
