VALUATION REPORT

SITUATED AT
RAHI TOURIST BUNGALOW, KHASRA NO. 329 & 330 MIN. MADWANAGAR,
BADEBAN, BASTI

THE DEPARTMENT OF TOURISM, GOVERNMENT OF UTTAR PRADESH

U.P. TOURISM
(RAHI TOURIST BUNGALOW BASTI)

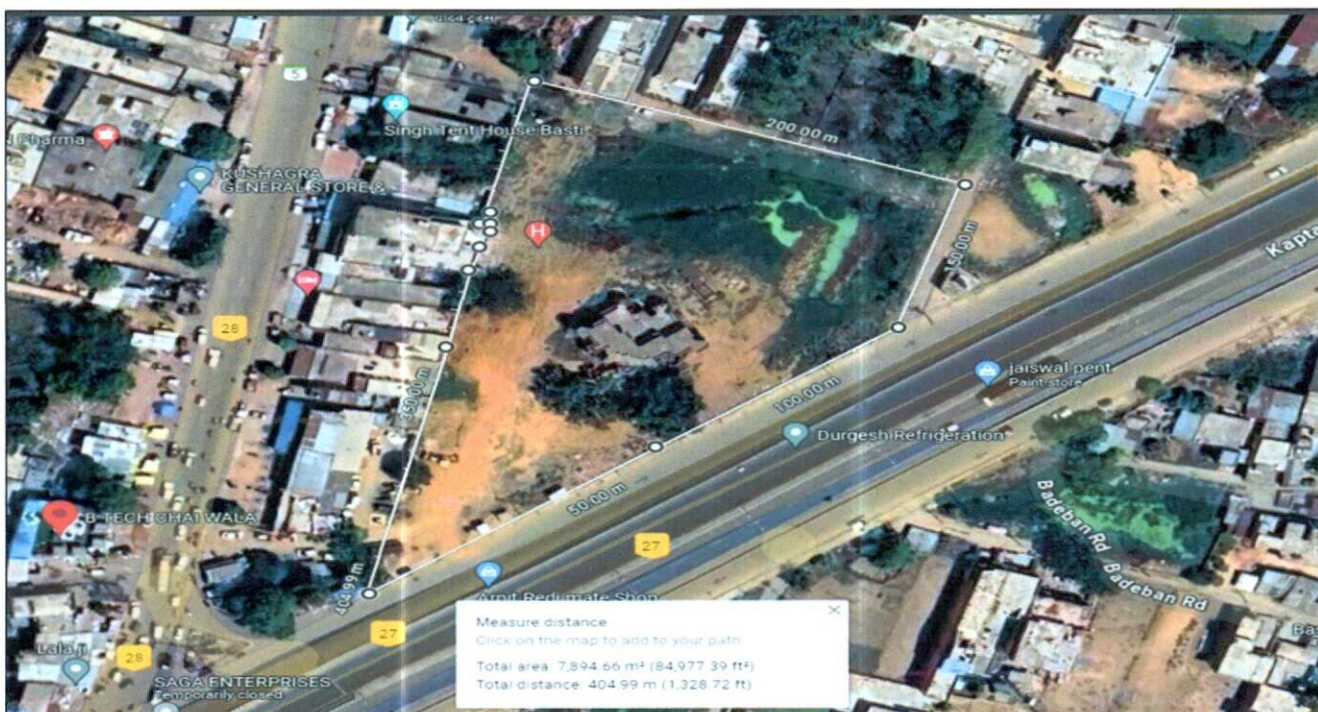
During the site visit it was observed that the property was not demarcated. Demarcation done by satellite measurement tool is as shown below:

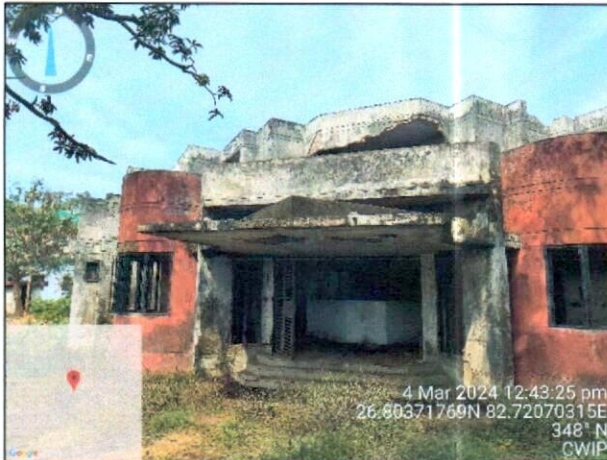
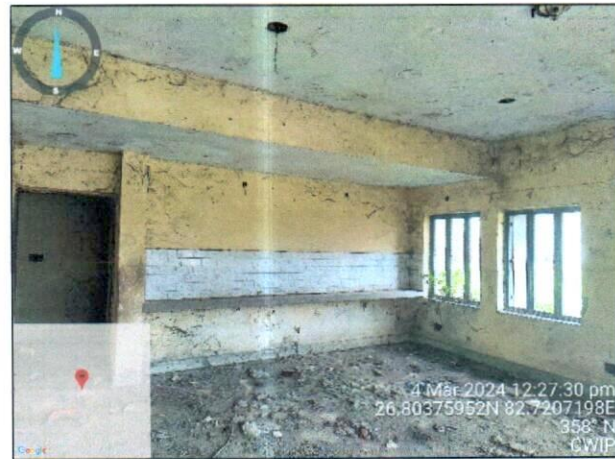
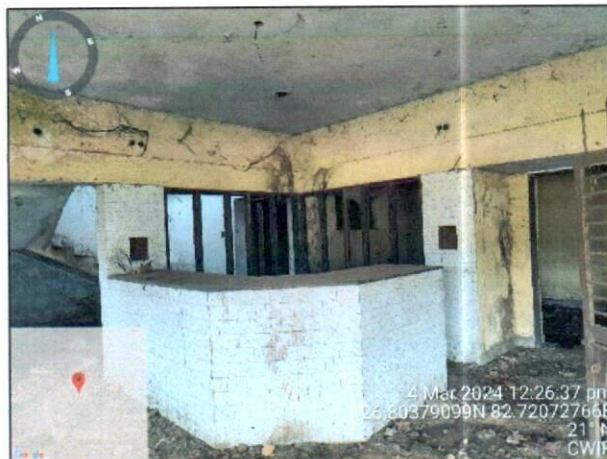
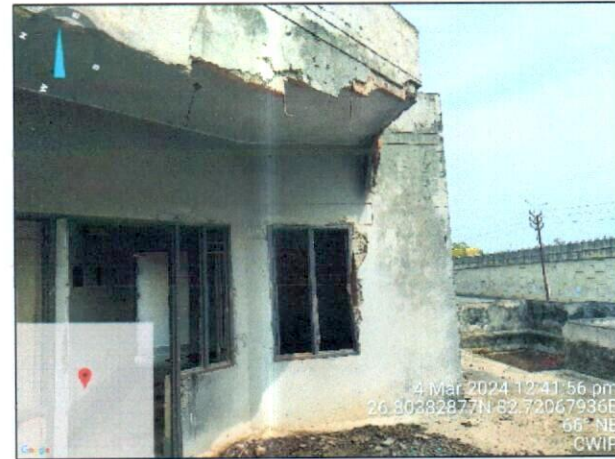
ENCLOSURE: 3- PHOTOGRAPHS OF THE PROPERTY

k) Class of sanitary & water supply fittings	Internal/ Sanitary & Water fittings were missing	
iv.	Maintenance issues	Building has structural issues with cracks are visible in the structure, Plaster of the structure is in bad condition

v.	Age of building/ Year of construction	~29	~1995
vi.	Total life of the structure/ Remaining life expected	~60 years	~31 years
vii.	Extent of deterioration in the structure	Building is in depleted condition	
viii.	Protection against natural disasters viz. earthquakes etc.	Since this is a RCC structure so should be able to withstand moderate intensity earthquakes. Comments are been made only based on visual observation and not any technical testing.	
ix.	Visible damage in the building if any	Visible cracks in the building
